## INDIGENOUS MONITOR OVERVIEW REPORT

**Month: September 2021**

**Project Region: BC Interior  
Spread 5A**

**Kilometre Posts (KPs) monitored:  
KP 806–927**

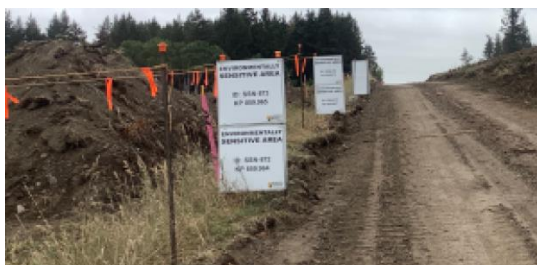
At KP 859, Indigenous Monitors were involved in inspecting the salvage and placement of topsoil and subsoil and were available if any potential heritage resources or items of TLU interest are unearthed during soil stripping. During the inspection, the Indigenous Monitor confirmed the soil piles were within the surveyed limits. No concerns were identified.

Soil piles within limits near KP 859.

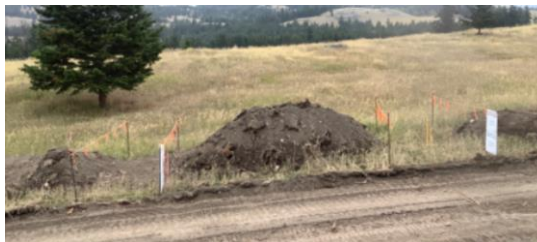
Wildlife corridors observed between topsoil piles at KP 859.

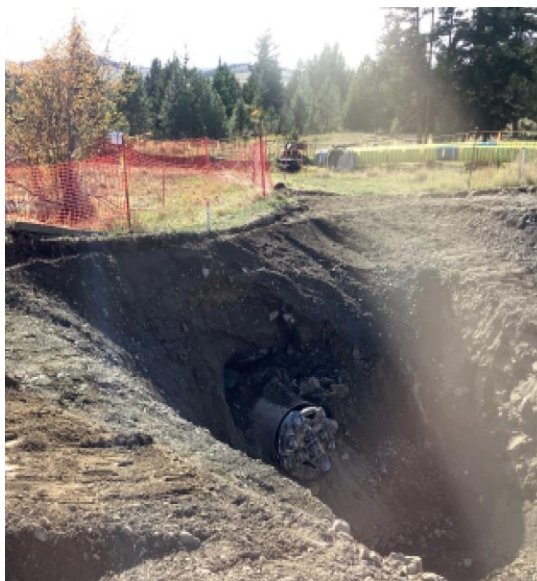
Near KP 825, Indigenous Monitors observed the above-construction method and monitored above-ground environmental features, ensuring flagging and signage remained in place. Cuttings from the drilling activities were inspected for artifacts and lithics. None were identified.

Trenchless construction methods observed at KP 825.

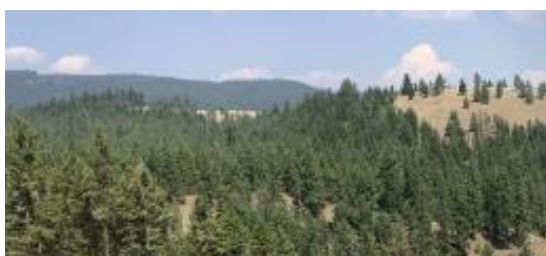
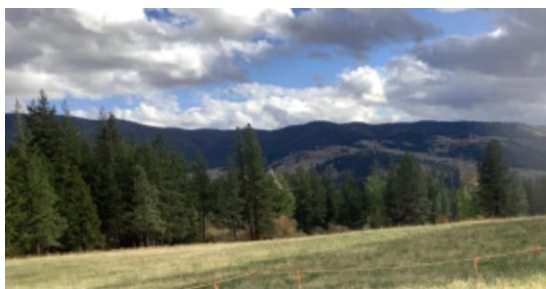
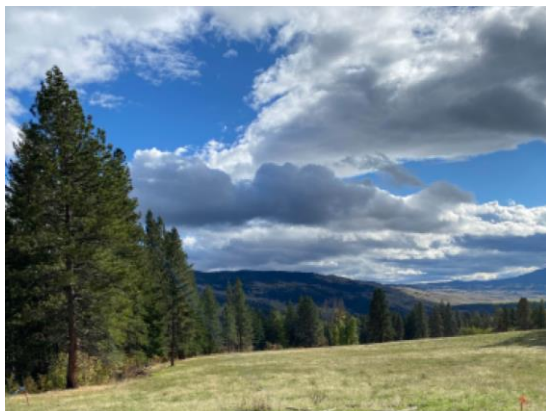
Near KP 927, the Indigenous Monitor participated in the implementation of the TLU Site Discovery Contingency Plan in areas where trees were identified that were thought to be potentially culturally modified. Indigenous Monitors continue conducting CMT sweeps ahead of construction activity. Trees found during a CMT sweep were examined by the Indigenous Monitors and Environmental Inspectors on-site to collect initial information. The area was flagged off for additional evaluation. Resource specialists and Knowledge Holders of IM's communities were contacted for evaluation of the tree and potential mitigation. The engagement process with applicable Indigenous groups was initiated to share information about the resource and seek feedback. The assessment of this resource is in progress.

General area around KP 930 where CMT sweeps were conducted.

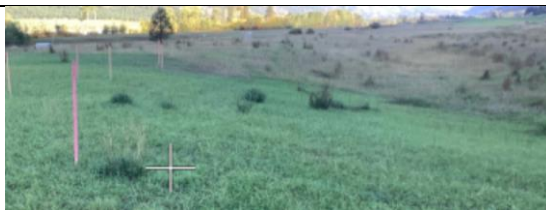
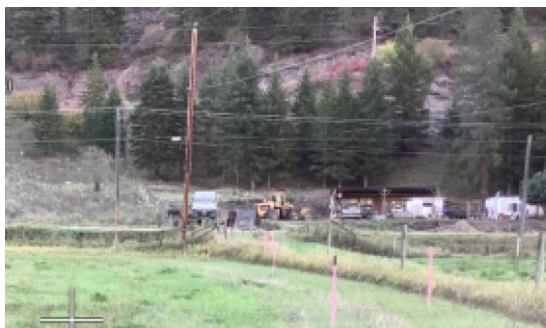
An inspection was conducted by an Environmental Inspector and an Indigenous Monitor at the Black Pines Transmission Line. The inspection included observing archaeological impact assessment crews, equipment using drip trays, on-site stormwater management, soil buffers and placement locations and TLU signage. No environmental concerns were recorded at the time of the inspection.

Black Pines Transmission Line general area.
