INDIGENOUS MONITOR OVERVIEW REPORT

Month: September 2021

Project Region: Lower Mainland

Indigenous Monitors on the Trans Mountain Expansion Project – Overview

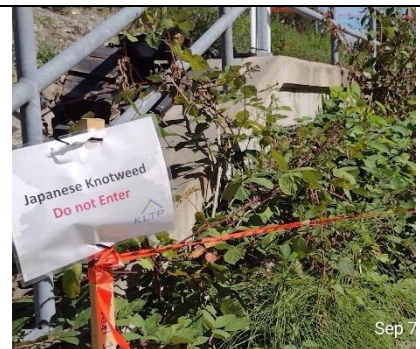
On Spread 7 at KP 1174.8, the Indigenous Monitor observed that additional signage and flagging was installed for the identification and containment of Japanese Knotweed, a common local invasive weed species. In the same area where the additional buffers were installed, the Indigenous Monitor identified that wooden material had been removed. They confirmed with the Environmental Inspector that any materials removed from an invasive weed species area is properly cleaned to prevent the potential spread to other weed-free areas.

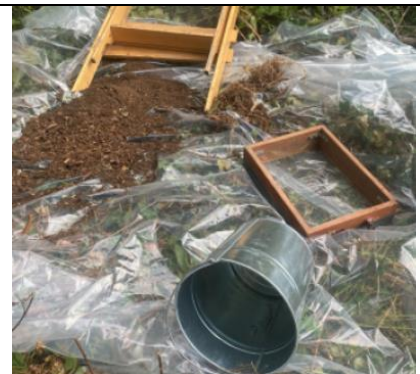
In September, the Indigenous Monitors observed Archaeological Impact Assessments (AIA) conducted near KP 1174. The assessments, completed by a qualified archaeologist and Indigenous participants, may include visual inspection to identify features with predictable archaeological potential, surface inspection of areas with exposed sediments for cultural materials and subsurface testing (shovel testing) of terrain features exhibiting archaeological potential.

Equipment used in AIA shovel testing on Spread 7.

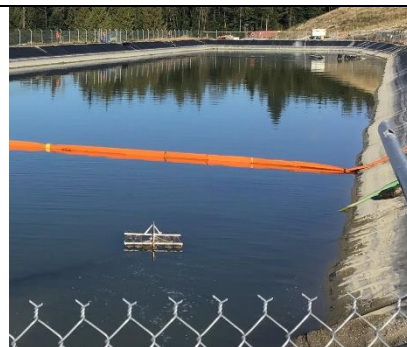
In September, in preparation for the forecasted heavy rainfall, the Indigenous Monitor observed the draining of the Intermediate Storm Water Retention Pond at Burnaby Terminal to avoid overflow of water before it could be pumped into the water treatment plant, cleaned, then discharged to the Tertiary Containment Area (retention pond). They also inspected the sensors at the retention pond to ensure weeds were not obstructing the readings.

Emptying water from the Intermediate Storm Water Retention Pond (ISWRA) in preparation for heavy rainfall.

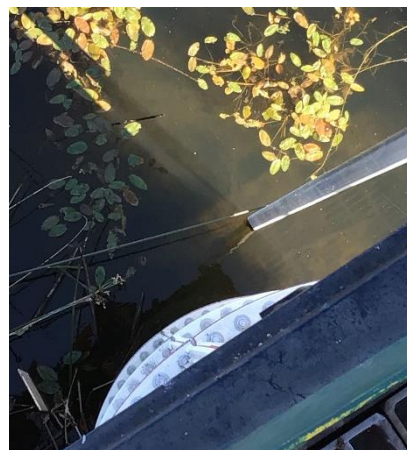
Checking sensors at the Burnaby Terminal retention pond.

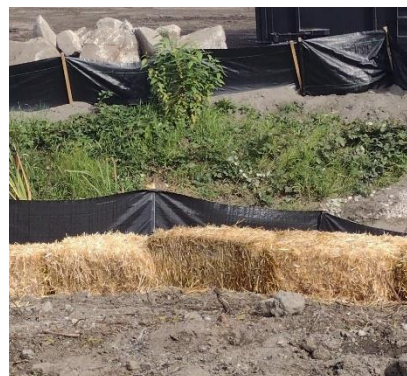
Straw bales and silt fencing functioning as intended at CWP 87.

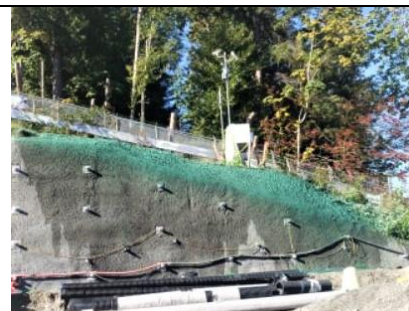
At WMT in preparation for the mid-September heavy rainfall, the Indigenous Monitor inspected the hydroseeding on an exposed slope near the manifold wall. The contractor was advised to cover the slope with polyethylene sheeting ahead of the expected rain event to ensure it did not get washed away.

Hydroseed to be covered by poly sheeting at WMT prior to forecasted heavy rainfall.

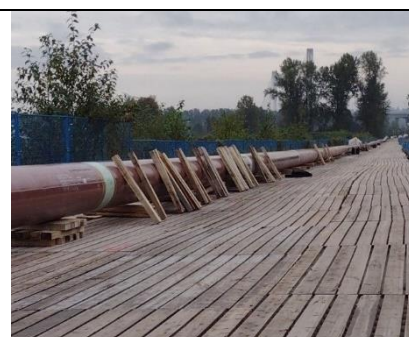
Assembling the pipe by welding and sandblasting occurs on the protective wood matting. Each morning before the pipe assembly crew begins activity, a sweep for snails and other small wildlife is conducted along the wood matting and adjacent worksite. Before welding activities can begin, fire retardant matts must be placed on top of the wood per the site fire safety plan.

Pipe stored on wooden protective matting on Colony Farm after being welded together. This pipe will be used for the Fraser River HDD.

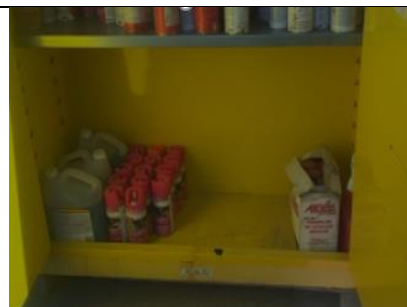
Example of proper storage of aerosol spray cans and other materials at CWP 75.
