INDIGENOUS MONITOR OVERVIEW REPORT

Month: June 2021

**Project Region: North Thompson
(Spread 3/4a and Spread 4b)**

**Kilometre Posts (KPs) Spread 4B:
697 – 764 and Spread 3/4A: 470 – 696**

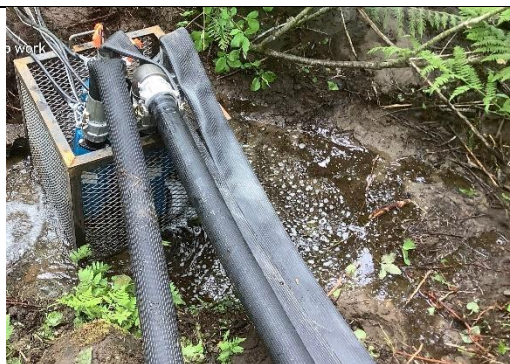
The Indigenous Monitor observed the contractor install diversion pumps and hoses used to divert the water for in-stream work to occur at watercourse BC 67A (KP 550.18). The upstream water is being diverted downstream of the crossing area to maintain natural flow conditions and water quality. Hoses were placed on plywood to reduce the potential impacts of topsoil scouring, soil erosion, and water quality turbidity increases. The Indigenous Monitor observed that the hoses were working as intended and water was flowing onto the plywood; no adverse environmental impacts were identified during the time of inspection.

BC 67A watercourse diversion pump and hoses.

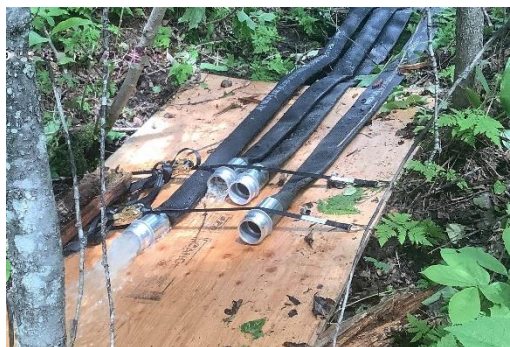
BC 67A watercourse diversion hoses on plywood.

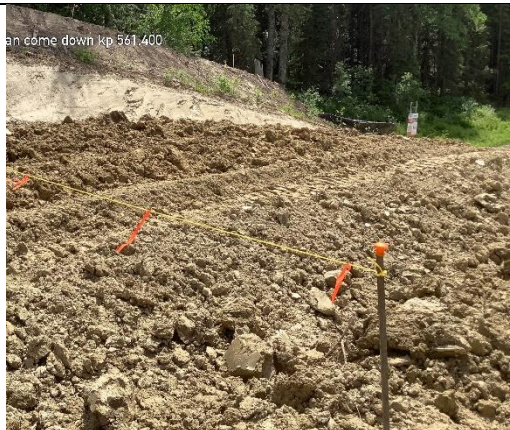
The Indigenous Monitor also participated in the Heritage Resource Site Discovery Plan for a bone fragment discovered near KP 561.44. After the contingency plan was executed, the archaeologist deemed the bone to be non-archaeological and the buffers were removed. No additional archaeological work in the area was recommended.

KP 561.44 where bone fragment was discovered and Heritage Resource Contingency Plan deployed. Deemed to not be of archaeological significance.

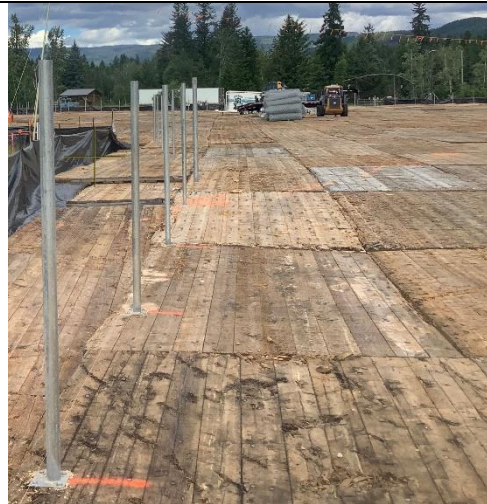
At the Raft River horizontal directional drill (HDD) entry pad (KP 712), the Indigenous Monitor observed the installation of protective wood matting. The matting will remain until construction activities at Raft River are completed. It will then be carefully removed by the contractor and any wooden debris will be cleaned up on the site. At the Blue River HDD site (KP 609.9), the Indigenous Monitor observed the removal of the protective matting and cleanup of residual woody debris.

Inspection of wood protective matting at the entrance to the Raft River HDD site.

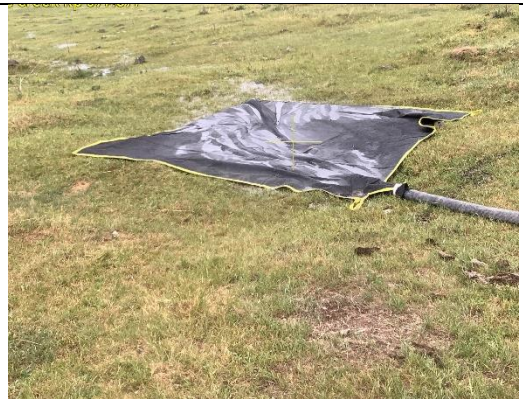
At Peavine Creek, surface water management continued as the team awaits approval to restart construction of the watercourse crossing isolated in-stream work. The Indigenous Monitor inspected the pump-off of water and filtration devices near Peavine Creek on a regular basis. Inspections are completed to monitor for sediment deposition, pooling and saturation of soils. Pump-off locations are revised based on site conditions observed during inspections.

New pump-off site selected for Peavine Creek de-watering

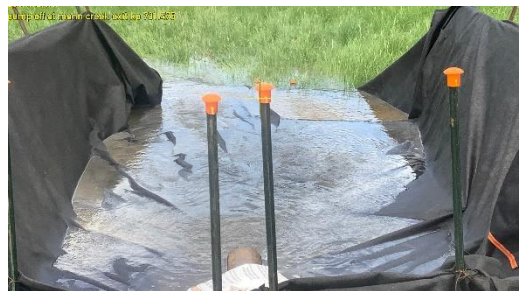
At the Mann Creek horizontal directional drill (HDD) exit site, hydrostatic testing was performed prior to installation of the pipe. The water used for hydrostatic testing was discharged to a location approved by the Environmental Inspector and was observed to be compliance with the Oil and Gas Commission's regulations on discharge of hydrostatic testing water. The Indigenous Monitor observed the discharging of the water and observed that no pooling occurred, water did not enter surface waterbodies or watercourses and that erosion did not result from the de-watering process.

Hydrostatic testing water being discharged at the Mann Creek HDD exit site.

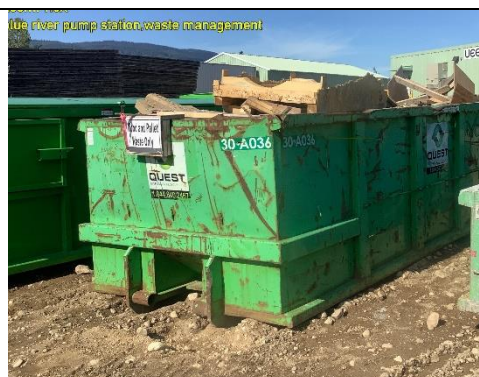
Following the measures outlined in Trans Mountain's Facilities Environmental Protection Plan, the inspections included site general housekeeping, waste segregation, recycling and metal disposal, and equipment inspections (ensuring proper use of drip trays). Two minor deficiencies were observed which included a wood recycling bin that required replacement as it was at capacity and a small amount of construction debris on the ground. Both items were resolved.

Wood recycling bin at Blue River Pump Station that was replaced with an empty bin.
